**Flood Control Project Maintenance
Levee Inspections**
LMA District Cover Sheet
Spring 2017 Levee Inspection Results

Reclamation District No. 0341 Sherman Island

Spring 2017 Levee Inspection Results

| Waterway | | | Bank | Unit Miles |
|--|---|---|---|---|
| Unit No. 01 Threemile Slough | | | Right | 3.36 |

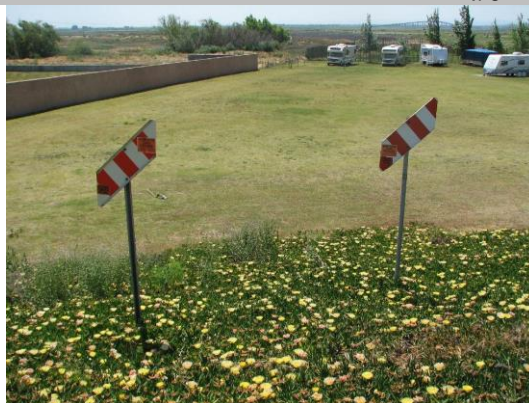
Photo 2 of 3 : UCIP_SP_2017_22306_38066.jpg

| FS_ID:22306 DS_ID:24130 EP_NO: 3494 Repair Type: Non-Urgent Crossing Status: Indicator Found UCIP Comments: Need to contact owner to determine status of crossing. Need date of last inspection and confirmation that crossing is still in operable condition. FIELD_STRUCT_DESC: 1 of 2: 26-inch concrete encased steel gas line through the levee, 5.1 feet below the crown. Concrete cutoff wall around pipe at center of levee. Location sign on waterward shoulder. Rock revetment on waterward slope. (Permit No. 3494-1961) Contact number listed on marker out in the field 1-800-811-4111. FS Date: 5/6/2009 | | | | | | |

Gas line markers visible on landward side.

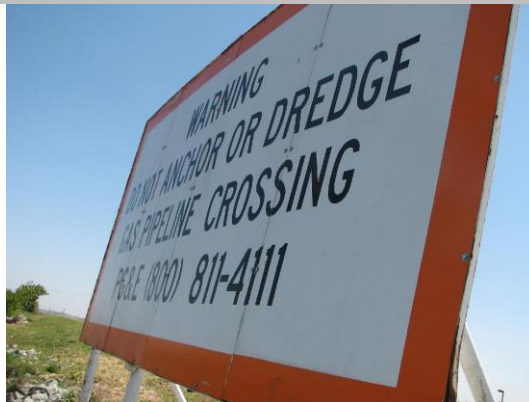
Photo 3 of 3 : UCIP_SP_2017_22306_38065.jpg

Gas line crossing sign located on waterward side.

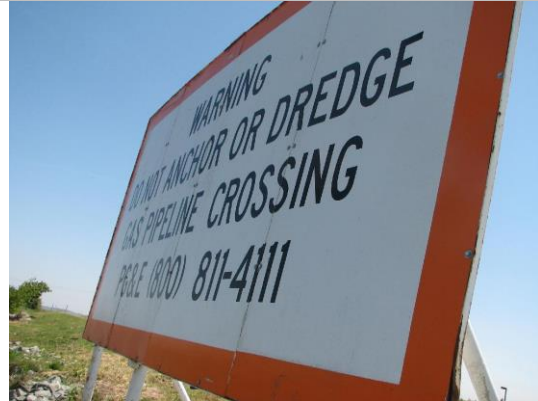
Photo 3 of 3 : UCIP_SP_2017_22307_38068.jpg

| FS_ID:22307 DS_ID:24233 EP_NO: 3494 Repair Type: Non-Urgent Crossing Status: Indicator Found UCIP Comments: Need to contact owner to determine status of crossing. Need date of last inspection and confirmation that crossing is still in operable condition. FIELD_STRUCT_DESC: 2 of 2: 26-inch concrete encased steel gas line through the levee, 5.1 feet below the crown. Concrete cutoff wall around pipe at center of levee. Location sign on waterward shoulder. Rock revetment on waterward slope. (Permit No. 3494-1961) Contact number provided on marker out in the field 1-800-811-4111. FS Date: 5/6/2009 | | | | | |

Gas line crossing sign located on waterward side.

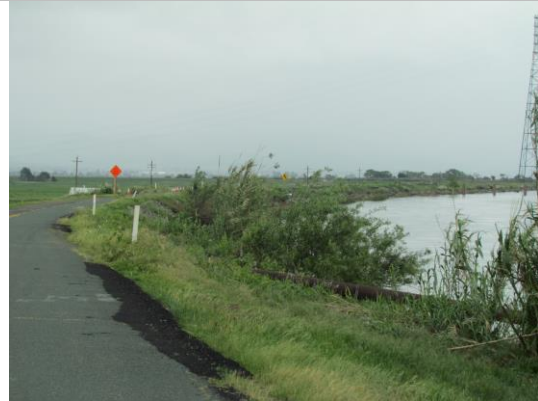
Photo 1 of 1 : SP_2017_RD0341_168_48_20170516_00086.jpg

RD 341 Waterside slope looking downstream from levee mile 8.49-8.65 bambo present on the slope.

| Control the growth of Bamboo from the waterside slope. | | | | | |

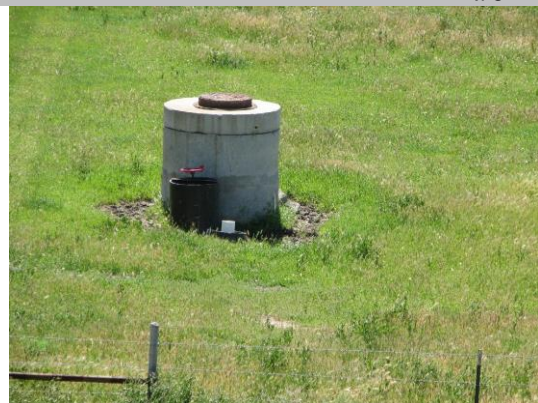
Photo 1 of 3 : UCIP_SP_2017_22309_38075.jpg

| FS_ID:22309 DS_ID:24247 EP_NO: N/A Repair Type: Non-Urgent Crossing Status: Found UCIP Comments: New record found in the field. Unable to find any information for crossing during DWR desk study. Will need to find the owner and obtain records for crossing. Need to coordinate with CVFPB. FIELD_STRUCT_DESC: 10-inch steel pipe through the levee, at a shallow depth below the crown. Air vent on the waterside (WS). Distribution box with slide gate and observation well on the landside (LS). Pumping station on the LS. Remaining piles present on waterside that show evidence of existing pump station could have been used for irrigation purposes. Rip rap located on waterward side. FS Date: 5/6/2009 | | | | | |

Concrete stand pipe and gate valve located on landward side.

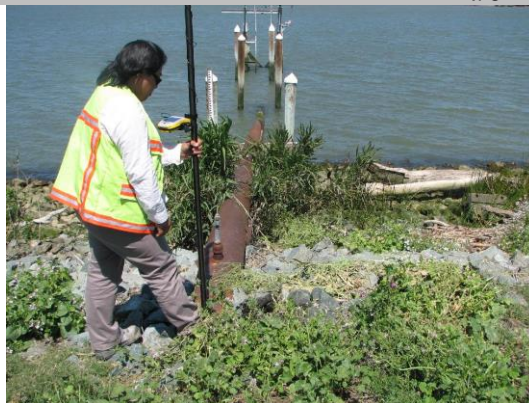
Photo 2 of 3 : UCIP_SP_2017_22309_38076.jpg

| UCIP Comments: New record found in the field. Unable to find any information for crossing during DWR desk study. Will need to find the owner and obtain records for crossing. Need to coordinate with CVFPB. | | | | | | |

Overview of crossing on waterward side.

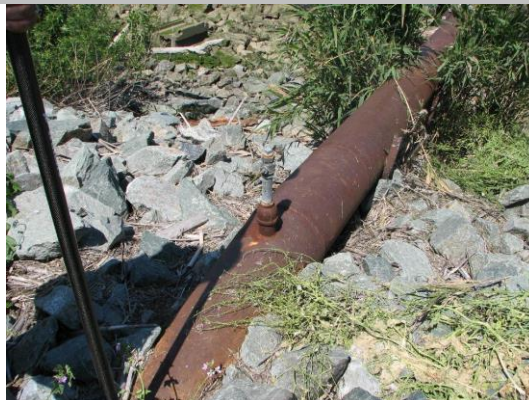
Photo 3 of 3 : UCIP_SP_2017_22309_38077.jpg

Siphon breaker visible on waterward side. Levee toe is armored with rock slope protection.

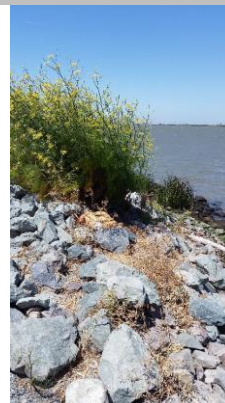
Photo 1 of 3 : UCIP_SP_2017_50082_75941.jpg

| FS_ID:50082 DS_ID:25470 EP_NO: N/A Repair Type: Non-Urgent Crossing Status: Found UCIP Comments: 7/6/2016 Pipe found in 2009 has been removed and new pipe installed. Unable to determine permit authorizing work. Need to coordinate with owner to obtain details regarding permit and pipe install. (DWR UCIP - omagana) FIELD_STRUCT_DESC: UNK size pipe through the levee. (unknown permit authorizing work; previous 12-inch pipe removed between 2009-2016, pipe authorized under Automatic Board Order (ABO) issued as Permit No. 11108, 1975 - D. Faria) FS Date: 7/6/2016 | | | | | |

View of WS.

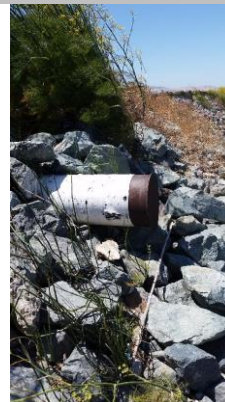
Photo 2 of 3 : UCIP_SP_2017_50082_75942.jpg

New pipe(non-functional) metal plate installed on the WS.

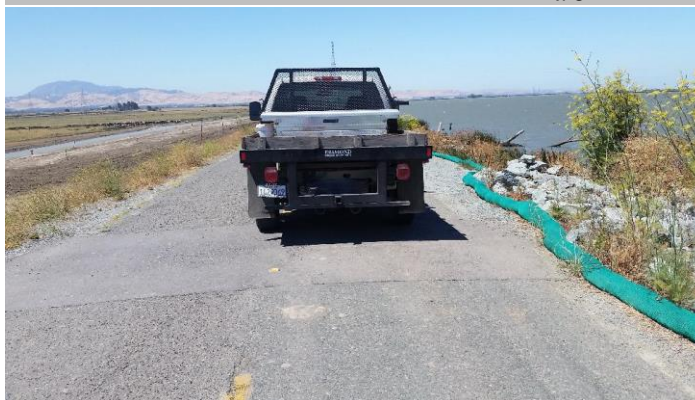
Photo 3 of 3 : UCIP_SP_2017_50082_75943.jpg

| UCIP Comments: 7/6/2016 Pipe found in 2009 has been removed and new pipe installed. Unable to determine permit authorizing work. Need to coordinate with owner to obtain details regarding permit and pipe install. (DWR UCIP - omagana) | | | | | | |

View of levee crown.

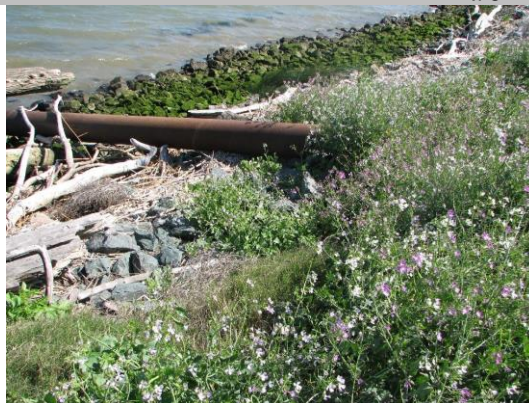
Photo 1 of 3 : UCIP_SP_2017_22324_38096.jpg

| FS_ID:22324 DS_ID:24133 EP_NO: 11114 Repair Type: Non-Urgent Crossing Status: Found UCIP Comments: Dense vegetation limits the inspector's visibility to identify signs of pipe failure (leaks) along the slope. Recommend removing vegetation along pipe alignment to conduct proper inspection of structure and appurtenances. FIELD_STRUCT_DESC: 14-inch pipe through the levee, 4.0 feet below the crown. Concrete standpipe with slide gate on landward side. Rock revetment on waterward slope. This pipe was retained under ABO No. 11114 (1975). FS Date: 5/6/2009 | | | | | |

Overview of waterward side.

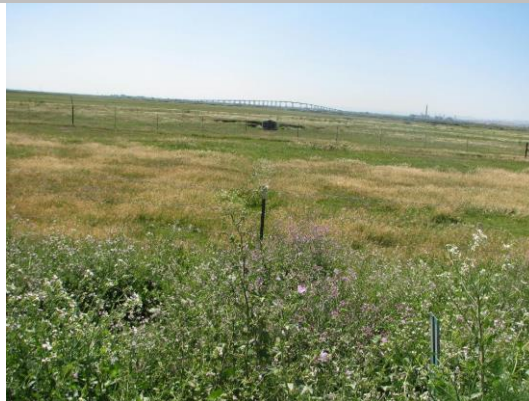
Photo 3 of 3 : UCIP_SP_2017_22324_38094.jpg

| FS_ID:22324 DS_ID:24133 EP_NO: 11114 Repair Type: Non-Urgent Crossing Status: Found UCIP Comments: Dense vegetation limits the inspector's visibility to identify signs of pipe failure (leaks) along the slope. Recommend removing vegetation along pipe alignment to conduct proper inspection of structure and appurtenances. FIELD_STRUCT_DESC: 14-inch pipe through the levee, 4.0 feet below the crown. Concrete standpipe with slide gate on landward side. Rock revetment on waterward slope. This pipe was retained under ABO No. 11114 (1975). FS Date: 5/6/2009 | | | | | | |

Overview of landward side.
